# Status of Livestock Water Sources in Karamoja Sub-Region, Uganda

Swidiq Mugerwa<sup>1,\*</sup>, Kayiwa Stephen<sup>1</sup>, Egeru Anthony<sup>2,3</sup>

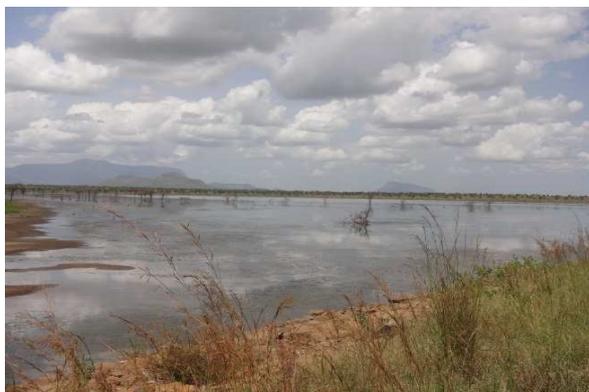
Figure 2. Nakicumet dam in Napak District

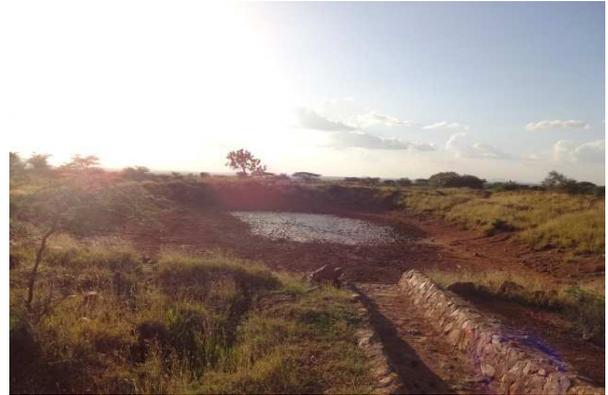
Figure 3. Lomario dam in Rupa, Moroto district

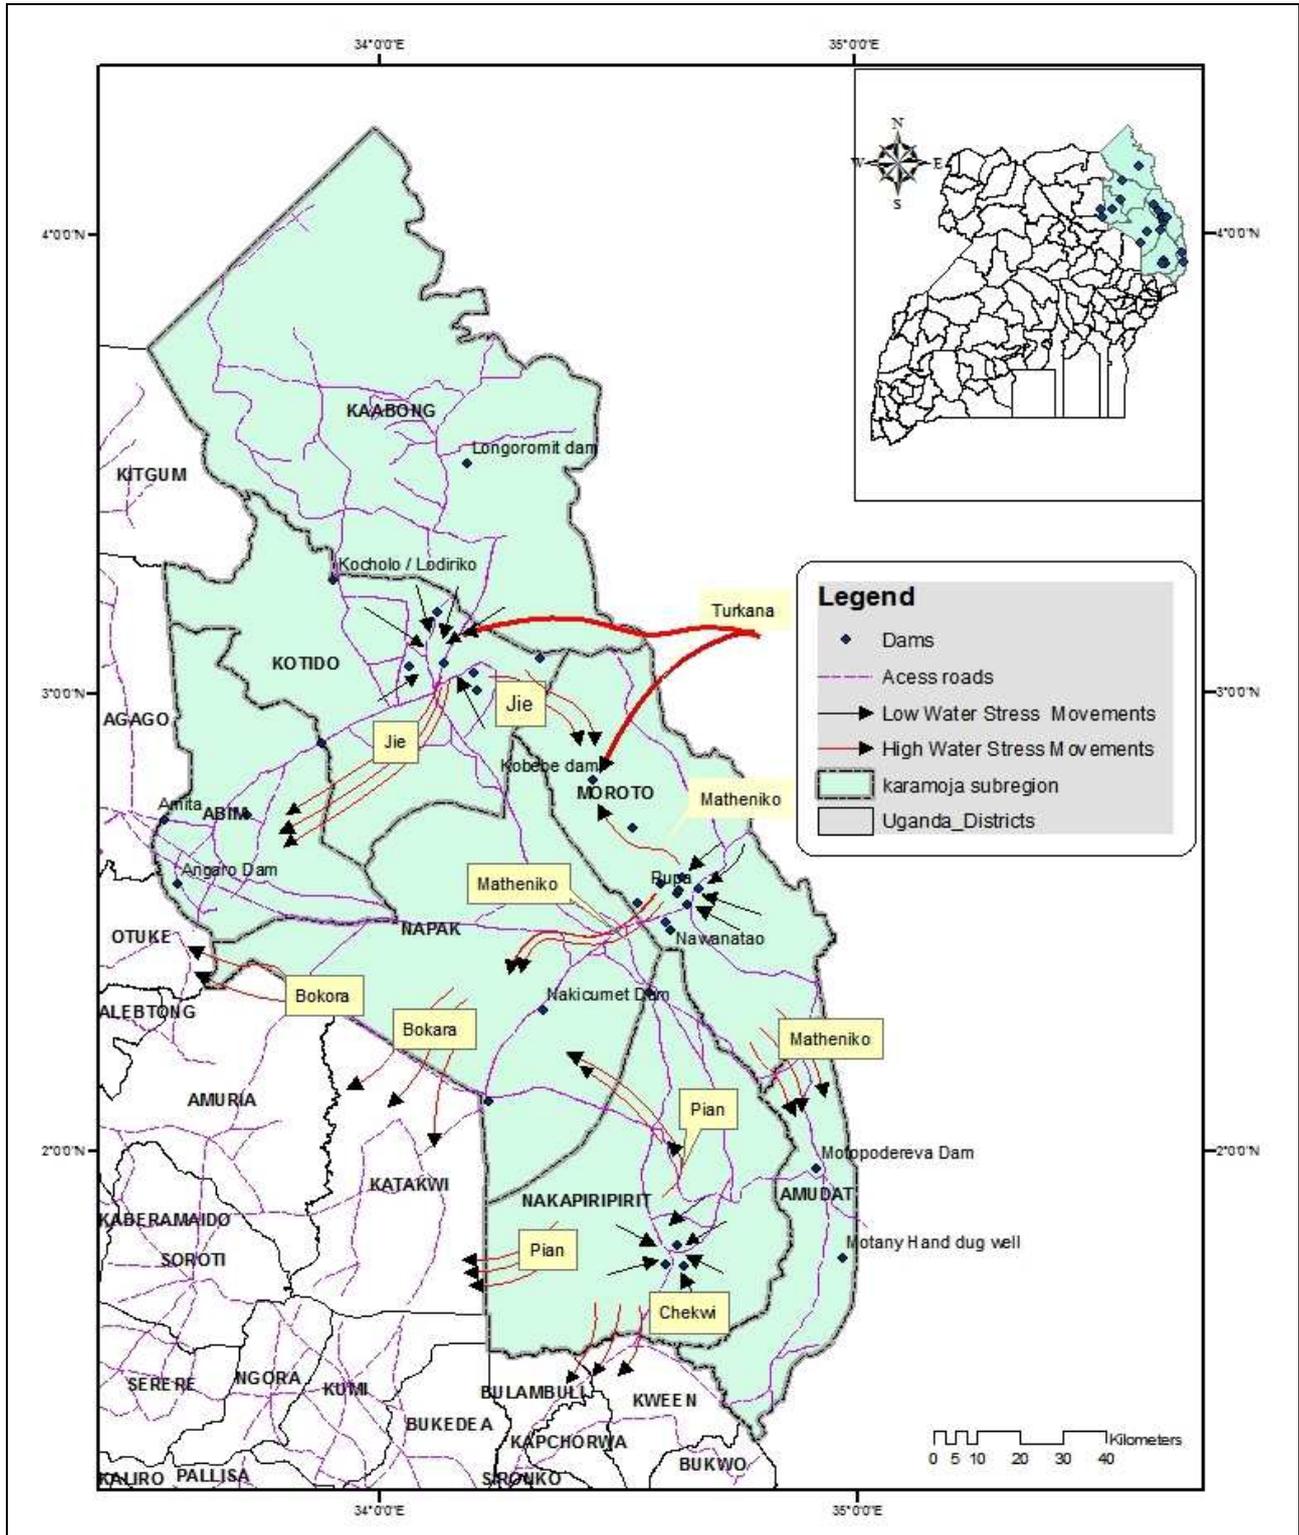
The distribution of dams in the three districts is non-uniform with the concentration of dams in a few sub-counties. In Moroto District for example, nine out of ten dams in the entire district are located in Rupa sub-county (Table 1; Figure 5). By the time the study was conducted (October-November, 2013), seven dams including Lokisilei, Kadilanke-Kanakol, Kanakol, Lomario, Kisop, Kidepo, Nawanatao, Pupu and Rupa had dried with only two dams (Kobebe and Kaloe) still holding some water. Observations revealed that the water in Kaloe dam could barely last up to mid-December-2013 implying that the livestock which were watering in this dam had to either move towards Kobebe or towards Arecke dam in Napak District. Further, minimal water sources for livestock exist in Katikekile sub-county yet the sub-county is classified as one of the pastoral livelihood zones in the sub-region. In Nakapiripirit, three of the four dams were located in Namalu with one dam found in Lonrengdwat and no dam was observed in other sub-counties such as Lolachat and Nabilatuk. Meanwhile, the dam at Lorengdwat was already dry by the time of the study. Additional information obtained from the herders indicated that the dam usually dries around late October to early November. Meanwhile in Napak District, Areceke-Nakicumet dam still had considerable volumes of water that could last through the dry season up to

Figure 5. Spatial distribution of dams and tribal movements of herders during periods of varying water stress

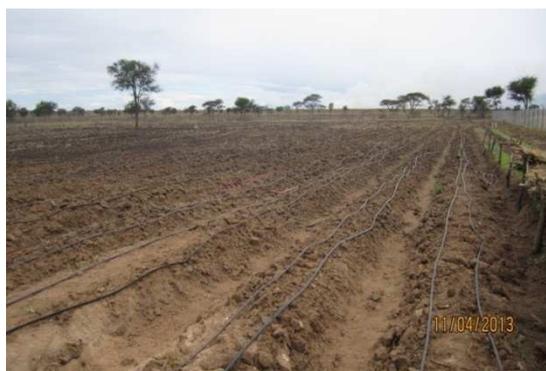
March/April of the following year. It is important to note that the water in Nakicumet dam is currently serving multiple benefits including irrigation purposes (Figures 6 and 7) and fish farming (one fish pond has been set-up at Nakicumet).

**Figure 6.** Prepared gardens laid with drip irrigation pipes at Nakicumet

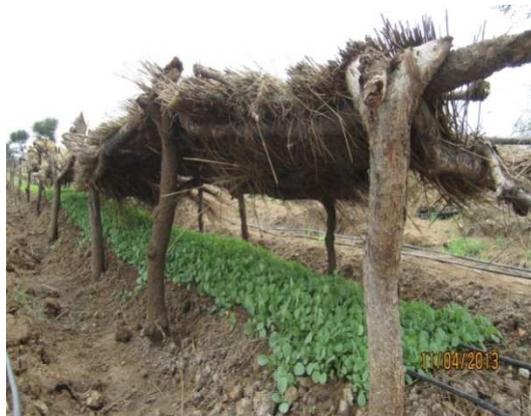
**Figure 7.** A seed bed of vegetables awaiting transplanting
